BUILDING USE AUDIT - CONDITION ASSESSMENT
Town of Hadley, Massachusetts

Goodwin Memorial Library

50 Middle Street

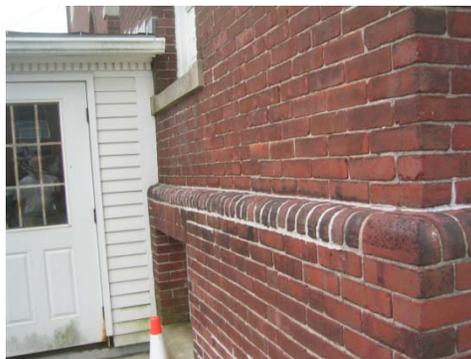
- The condition of the exterior brick is generally satisfactory, particularly considering the age of the facility. Repointing was conducted following the issue of the Ford Gillen Architects report in 2007. Apparently, the quarter round brick cap near the base of the building had deteriorated and creating a water infiltration problem. This element has now been repointed (Left

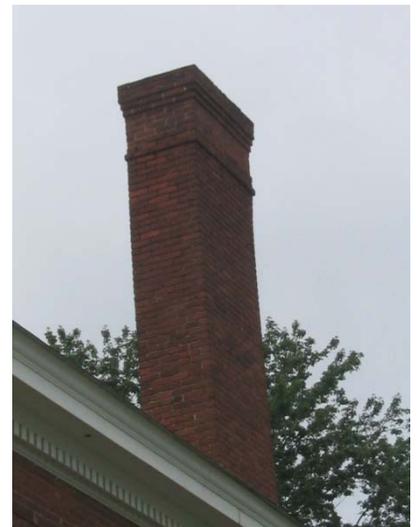
3 Repointing is still required in areas. The chimney (viewed from the ground) appears to be in relatively poor condition; further review is recommended.

Photo). Additional repointing is still required in some areas. The chimney (viewed from the ground) appears to be in relatively poor condition; further review is recommended (Right Photo).

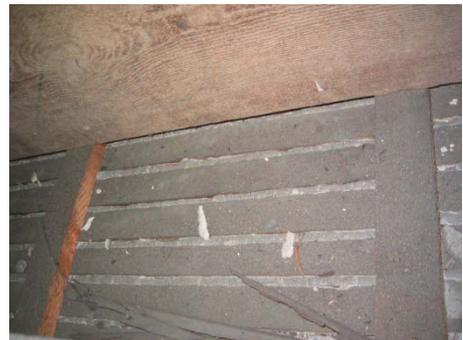
- The attachment of the plaster and lath ceiling of the Second Floor was reviewed in the area of the access hatch. The wood lath is nailed to the bottom of the ceiling joists; nails are permanently loaded in tension. In light of the age of the building and the shrinkage in the wood that may have occurred over time, FBRA recommends that ceiling attachments be inspected and supplemented, as necessary.
