BUILDING USE AUDIT - CONDITION ASSESSMENT
Town of Hadley, Massachusetts

Goodwin Memorial Library

50 Middle Street

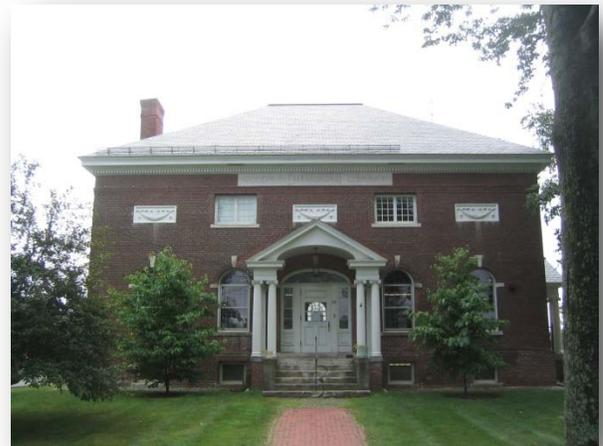
Program elements at the Basement Floor include stacks, storage rooms, restrooms and a mechanical space. The Basement is serviced by one stair at the back (northeast) section of the building. An exterior egress stair from this level is located on the east side. Collections, reference and computers are located at the (main) First Floor level. The Second Floor, accessed by two opposing stairs at the front (south) side of the building, is a large, open, unassigned space. There is no elevator; however, a handicap ramp was recently constructed along the east side of the building, wrapping around the south side and connecting to the main entrance.

The site slopes downwards (approximately ½ story) from the front (south) side to the back (north) side of the building. The Basement Floor is 5 to 6 feet below the average, exterior finished grade.
